# GATEMASTER GATE SAFETY RESTRAINER TEST REPORT

## ***Gate restrainer strength testing - GM F242/2020***

**Restraining Device Variation:** **GRS03 – Gate Restrainer, stainless steel, 3mm**  
 Maximum Gate Weight: 260kg  
 Recommended Maximum Gate Width: 2500mm  
*\*See loading chart at end of document for a detailed width v weight comparison*

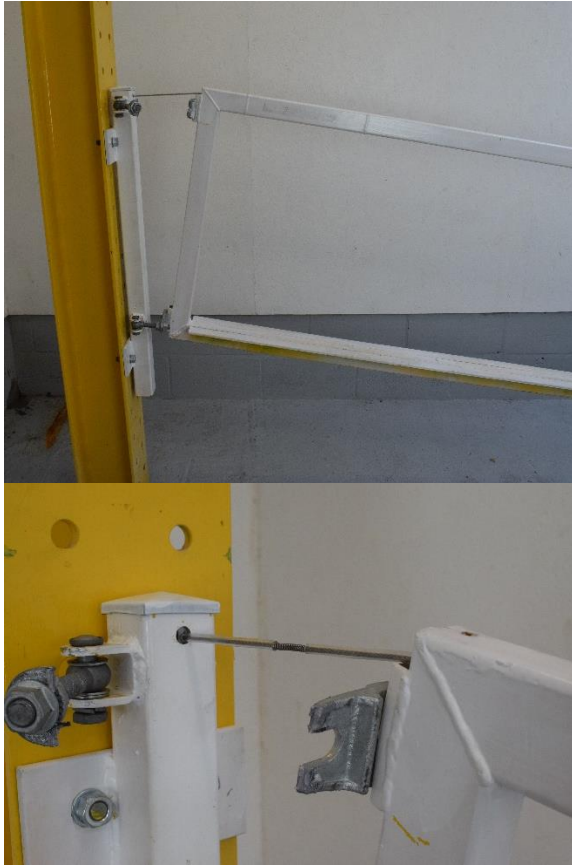
## Gate Setup

<b>Gate weight before loading</b>	30kg
<b>Box section wall thickness</b>	2mm
<b>Gate width</b>	2500mm
<b>Gate height</b>	800mm

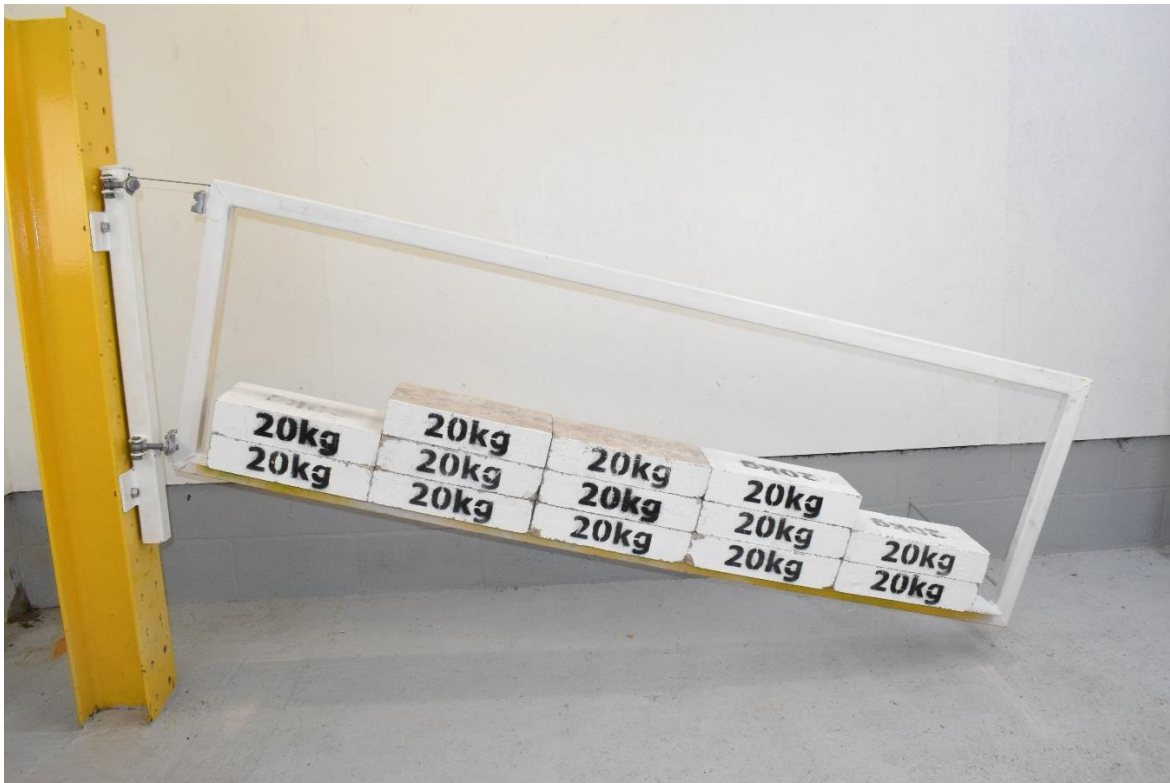
**Maximum weight – 260KG**

Restrainer failed at 280kg, due to failure of restraining plate end fixing. Bowing of restraining plates evident. Restrainer wire intact.
